**Flood Control Project Maintenance
Levee Inspections****LMA District Cover Sheet****Spring 2011 Levee Inspection Results****Reclamation District No. 2096 Wetherbee Lake**

Levee Inspection Report By Mile - Spring 2011

Waterway						Bank	Unit Miles	Inspection Start/End	Inspector
Unit No. 01 San Joaquin River						Right	0.17	04/12/2011 04/12/2011	Jim Eto

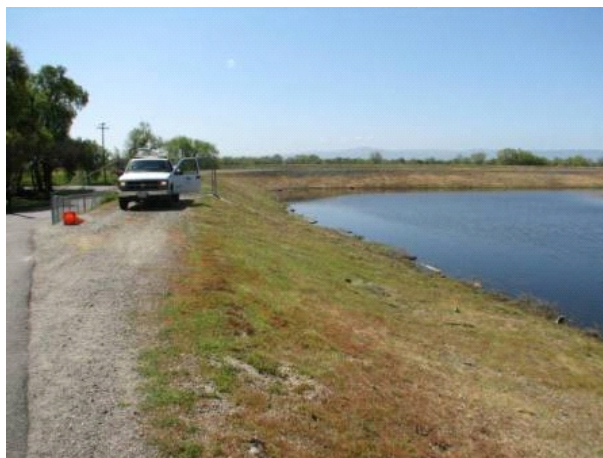
Levee Mile Report Line	2
Start Levee Mile	0.05
End Levee Mile	0.06
Location	Water Side
Category	Earthen Levee
Item	Vegetation

04/12/2011 Photo shows area free of vegetation.

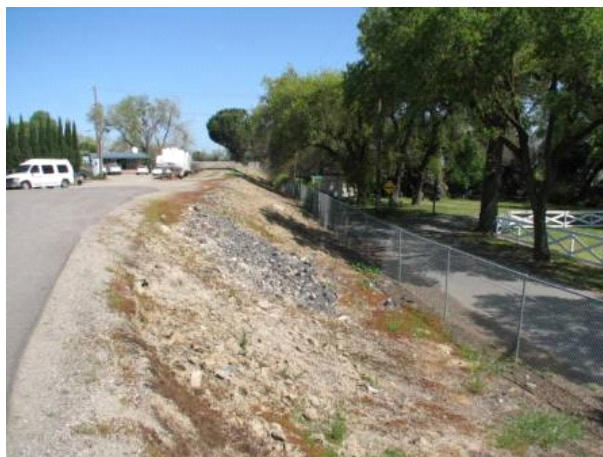
Levee Mile Report Line	2
Start Levee Mile	0.05
End Levee Mile	0.06
Location	Water Side
Category	Earthen Levee
Item	Vegetation

04/12/2011 Photo is for reference, showing area free of vegetation.

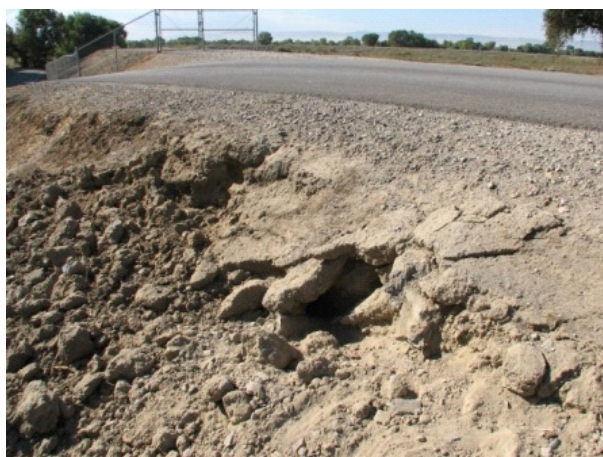
Levee Mile Report Line	4
Start Levee Mile	0.10
End Levee Mile	0.10
Location	Land Side
Category	Earthen Levee
Item	Animal Control

Levee slope was recompacted and rodents have reestablished their den at this location.

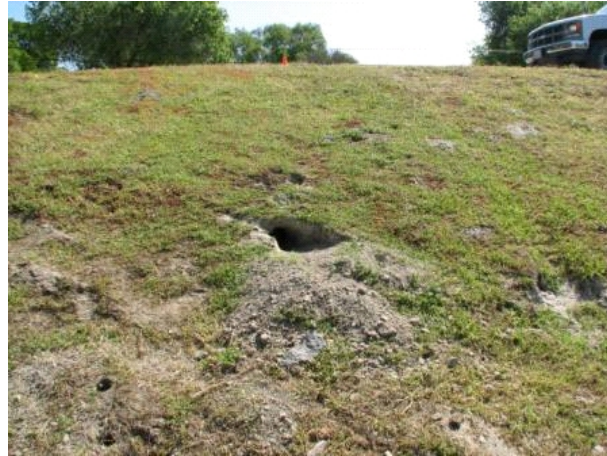
Levee Mile Report Line	4
Start Levee Mile	0.10
End Levee Mile	0.10
Location	Land Side
Category	Earthen Levee
Item	Animal Control
04/12/2011 Photo shows active burrows in levee on water side.	
jeto_s_20110412_381.jpg

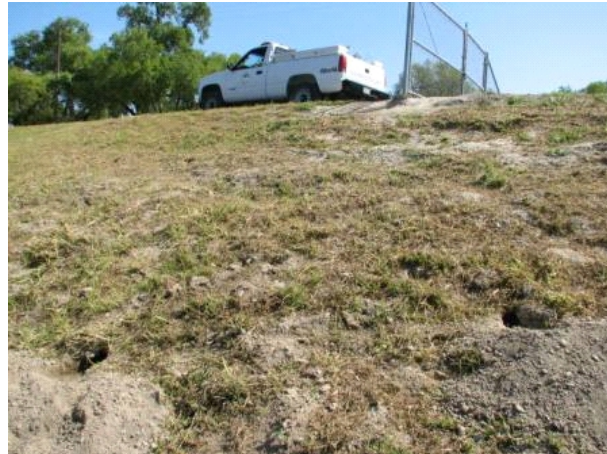
Levee Mile Report Line	4
Start Levee Mile	0.10
End Levee Mile	0.10
Location	Land Side
Category	Earthen Levee
Item	Animal Control
04/12/2011 Photo shows several burrows in same location, on water side of levee.	
jeto_s_20110412_382.jpg
